Evaluation of a Dust Control for a Small Slab-Riding Dowel Drill for Concrete Pavement

Alan Echt^a and Kenneth Mead^a

Purpose—To assess the effectiveness of local exhaust ventilation to control respirable crystalline silica exposures to acceptable levels during concrete dowel drilling.

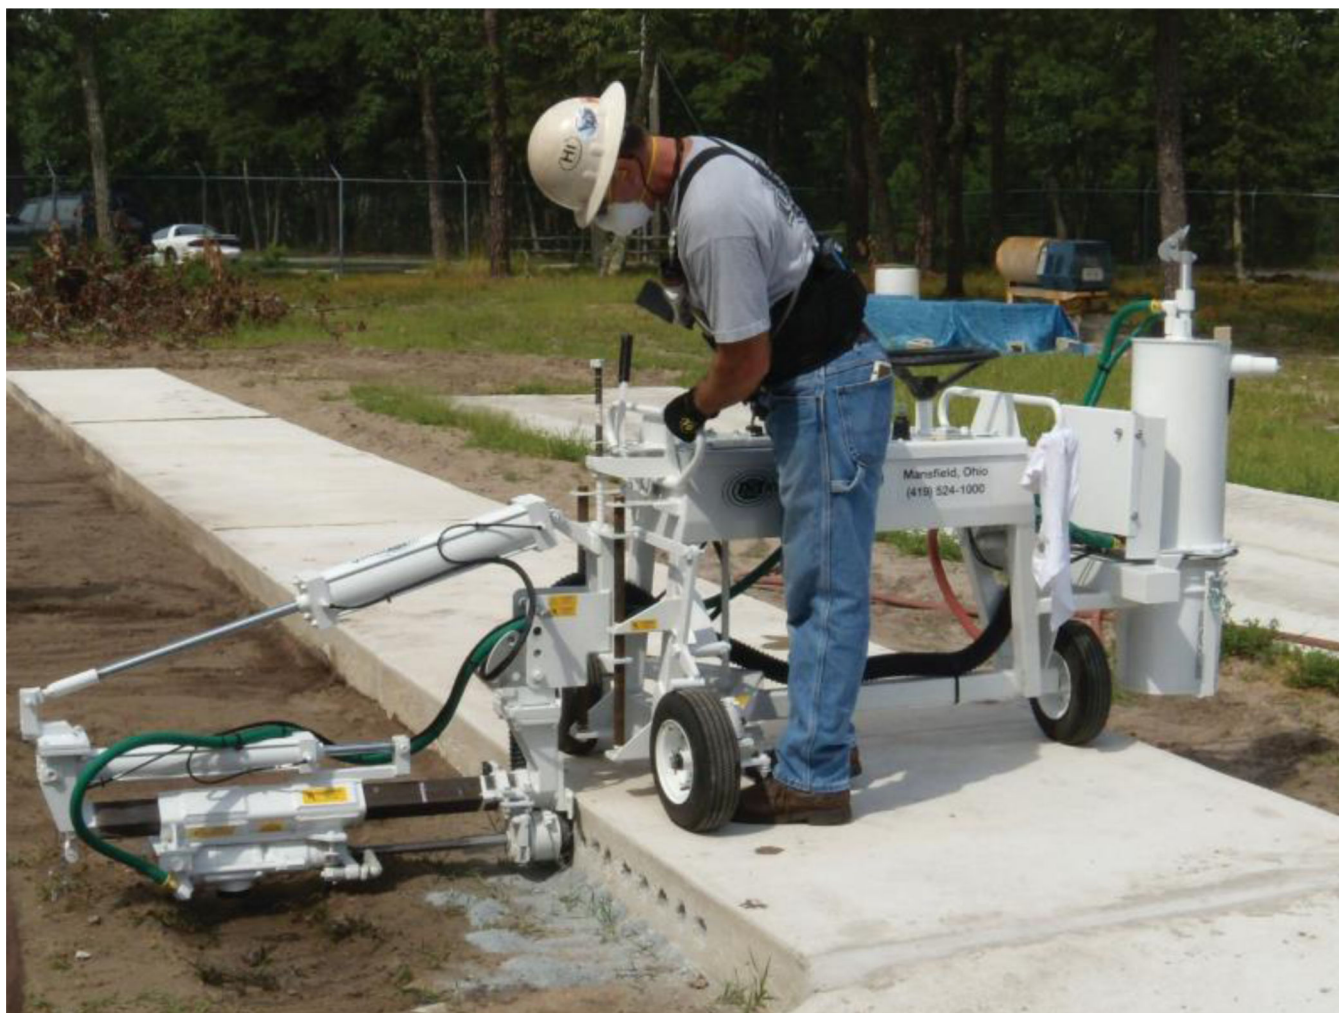
Figure 1.
Laborer operating dowel drill.

Dowel drilling was performed by two instructors at a Laborers training center. They took turns operating a new, single-drill slab-riding dowel drill (model A1C, Minnick Manufacturing Company, Inc., Mansfield, OH, USA). The drill was equipped with the manufacturer's dust collection system.

The drill used H-thread steels and bits to drill 3.5 cm diameter horizontal holes 36 cm into the side of a new 4000 psi air-entrained concrete slab, 9.1 m long by 1.5 m wide by 23 cm high. The bit shank was surrounded by a hood attached to 5 cm diameter corrugated flexible hose (the interior was also corrugated), attached to a dust collector at the back of the dowel drill; a pneumatic eductor on top of the dust collector (Fig. 1) pulled the control air through a pleated filter cartridge with a minimum efficiency reporting value (MERV) of 13 (P148646-016-340, Donaldson Company, Inc., Bloomington, MN, USA). During operation, captured dust built up on the filter cartridge to create a dust cake. As the dust cake accumulates on the filter, filtration efficiency increases but so does the air flow resistance (ACGIH, 2010). The drill operator periodically cleaned the filter by triggering a reverse pulse jet. At the bottom of the dust collector, a plastic bucket collected accumulated dust. This bucket was dumped when the laborer noticed visible dust around the surface of the drill. The laborer also removed and manually cleaned the filter at that time.
